GERMAN SELF-PROPELLED GUNS

Self-propelled artillery
anti-tank and anti-aircraft guns

Gordon Rottman

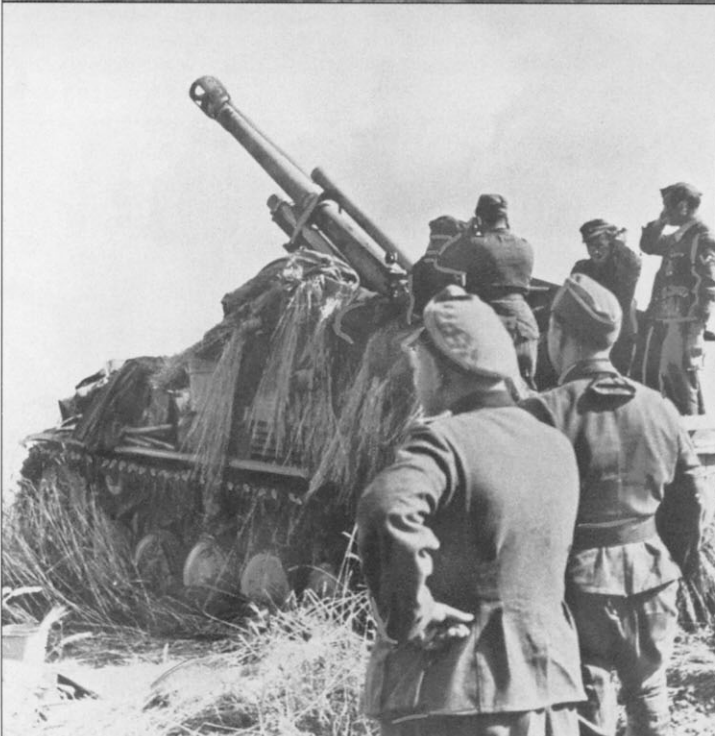
A 'Wespe' cracks out rounds at Soviet positions. The 10.5cm le.F.H.18/2 Fahrgestell auf Geschützwagen Pz.Kpfw.II or 'Wespe' (Wasp) was also known as the leichte Feldhaubitze 18/2 auf Fahrgestell Pz.Kpfw.II (Sf.) (Sd.Kfz.124). The 'Wespe' mounted a le.F.H.18/2, the same as used as towed artillery in divisional artillery regiments. The 'Wespe' was built on a Pz.Kpfw.II Ausf.F chassis modified by relocating the engine in a central position to allow space for the gun compartment. A total of 676 were built in 1943-44. This vehicle has been fairly well camouflaged with bundles of wheat. The oval object behind the neck of the foreground officer to the right is a leather binocular eyepiece cover used when the binoculars were slung around the neck and were not protected by its case. It was commonly slid on the strap out of the way behind the neck.

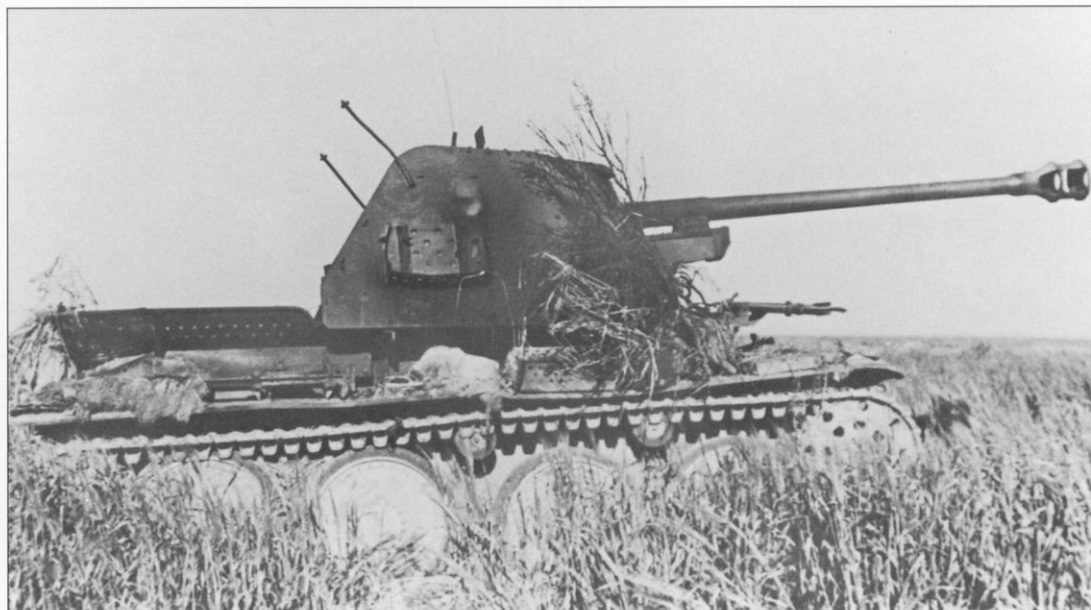
The right profile of a 7.5cm PaK 40/3 auf Pz.Kpfw.38(t) Marder III Ausf.H. The horizontal apparatus below the gun barrel is the barrel lock lowered for firing. Beneath it can be seen the barrel of the 7.92mm MG-37(t) (Czechoslovak vz.37) machine gun mounted in the center of the bow compartment. It did not carry an MG-34 machine gun internally in the gun compartment as did the Ausf.M.

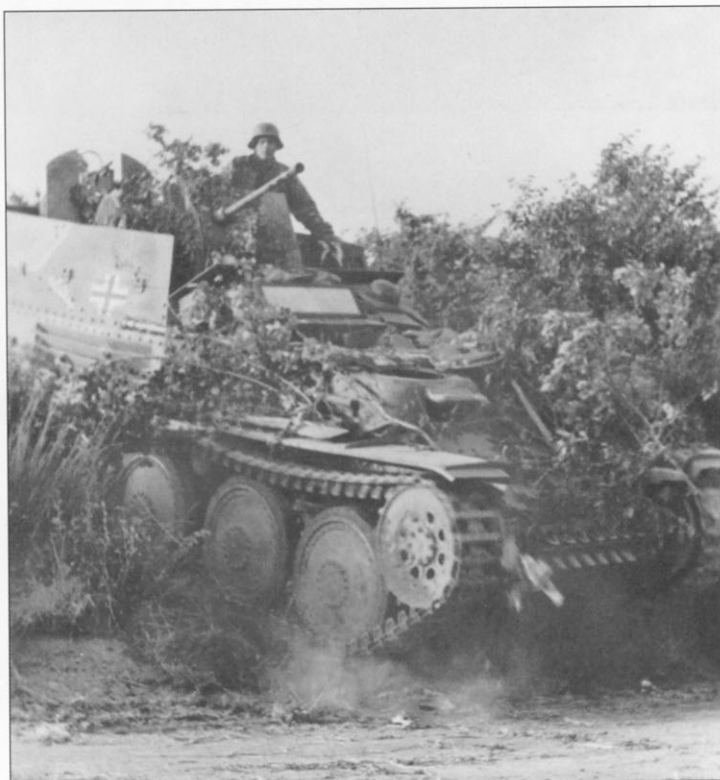
A Flakpanzer 38(t) busts out of the brush. Note that its hinged armored side panels are raised. They were lowered to place the 2cm gun in operation.
